Manhole Inspection Summary

Manhole # S39YY_005MH

Insp Date: **12/15/06 1:40 PM**

Location Address: **703 33RD ST**

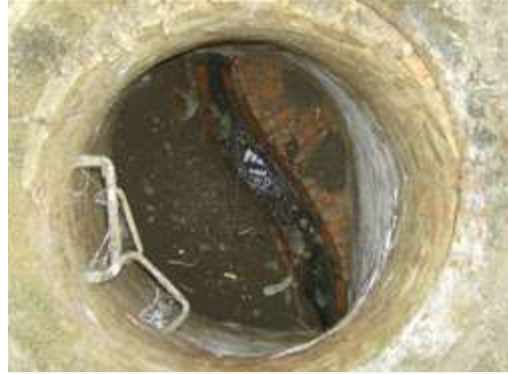
Top View

Barrel infiltration. Evidence of surcharge - Bench debris. Channel debris.

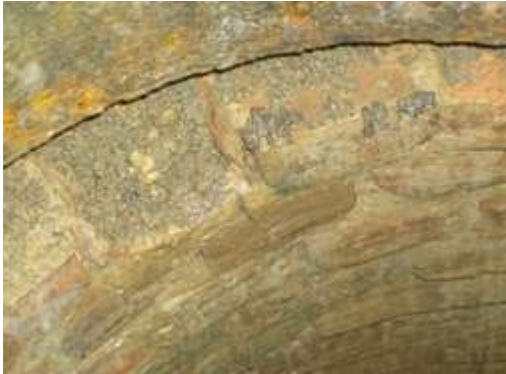
Defect

Frame leaks. Frame offset. Adjustment deterioration and infiltration.

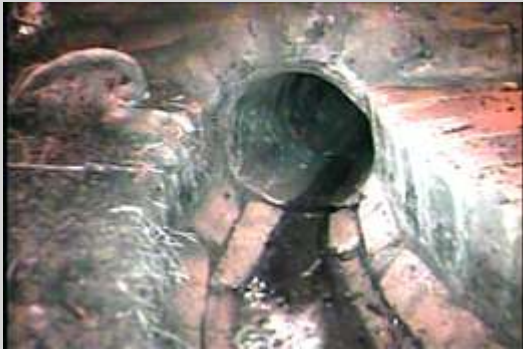
8 in. Circular Gravity Sewer Pipe Out @ 12 O'Clock

Bench root intrusion. Channel deterioration.

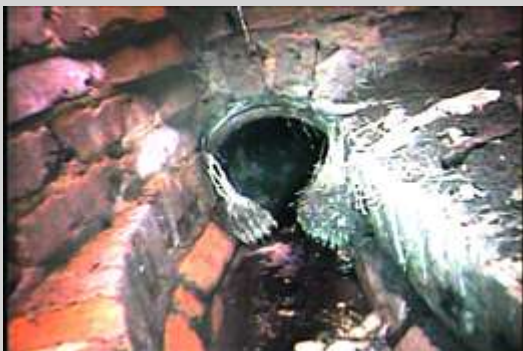
8 in. Circular Gravity Sewer Pipe In @ 6 O'Clock

Barrel deterioration and infiltration. Channel deterioration and root intrusion. Bench root intrusion.

Deposits: ☐ None ☒ **Mud** ☐ Sludge ☐ Debris ☐ Grease

Silt Depth: **0.5** (in.) Deposits Extent: **Light**

Infiltration: **Evidence** Pipe Seal Cond: **Roots**
